Moisture and Fungal Growth Assessment Report

City of Burien Community Center Annex
425 SW 144th St
Burien, King, Washington

January 15, 2020
Terracon Project No. 81207008

RE: Moisture and Fungal Growth Assessment
Burien Community Center Annex
14700 6th Avenue SW
Burien, Washington 98166
Terracon Project No. 81187154

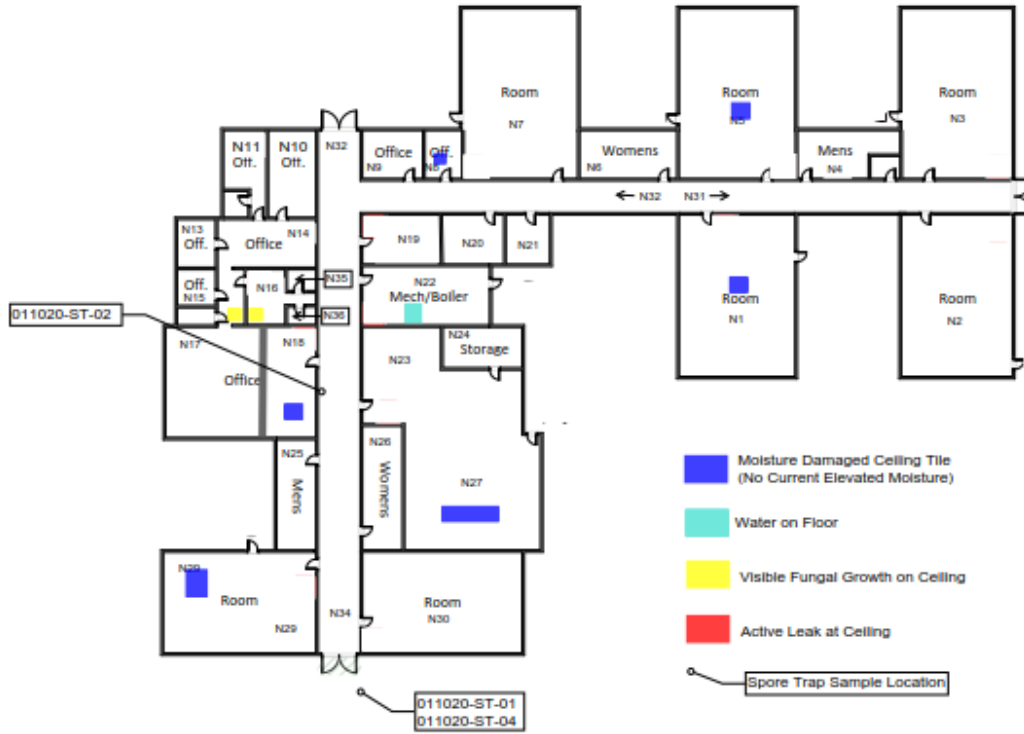
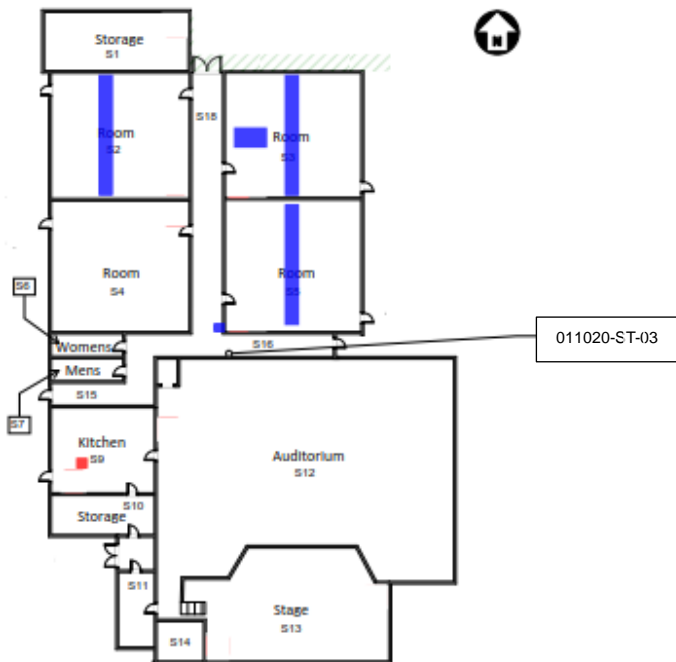
ASSESSMENT DIAGRAM & SPORE TRAP SAMPLING LOCATIONS

- Two outside control samples were collected for comparison with indoor results.
- One sample was collected in the Hallway N34 in the North Building.
- One sample was collected in the Hallway S16 in the South Building.

Terracon also observed the presence of acoustic ceiling tile with evidence of previous moisture damage in locations throughout the North and South Buildings (staining). No remaining elevated moisture was noted at these locations. The locations where moisture damaged ceiling tiles were identified are noted on the Assessment Diagram included in Appendix B.
