APPENDIX D

DAM RISK INVENTORY ASSESSMENT

D.1.0 DAM RISK INVENTORY ASSESSMENT

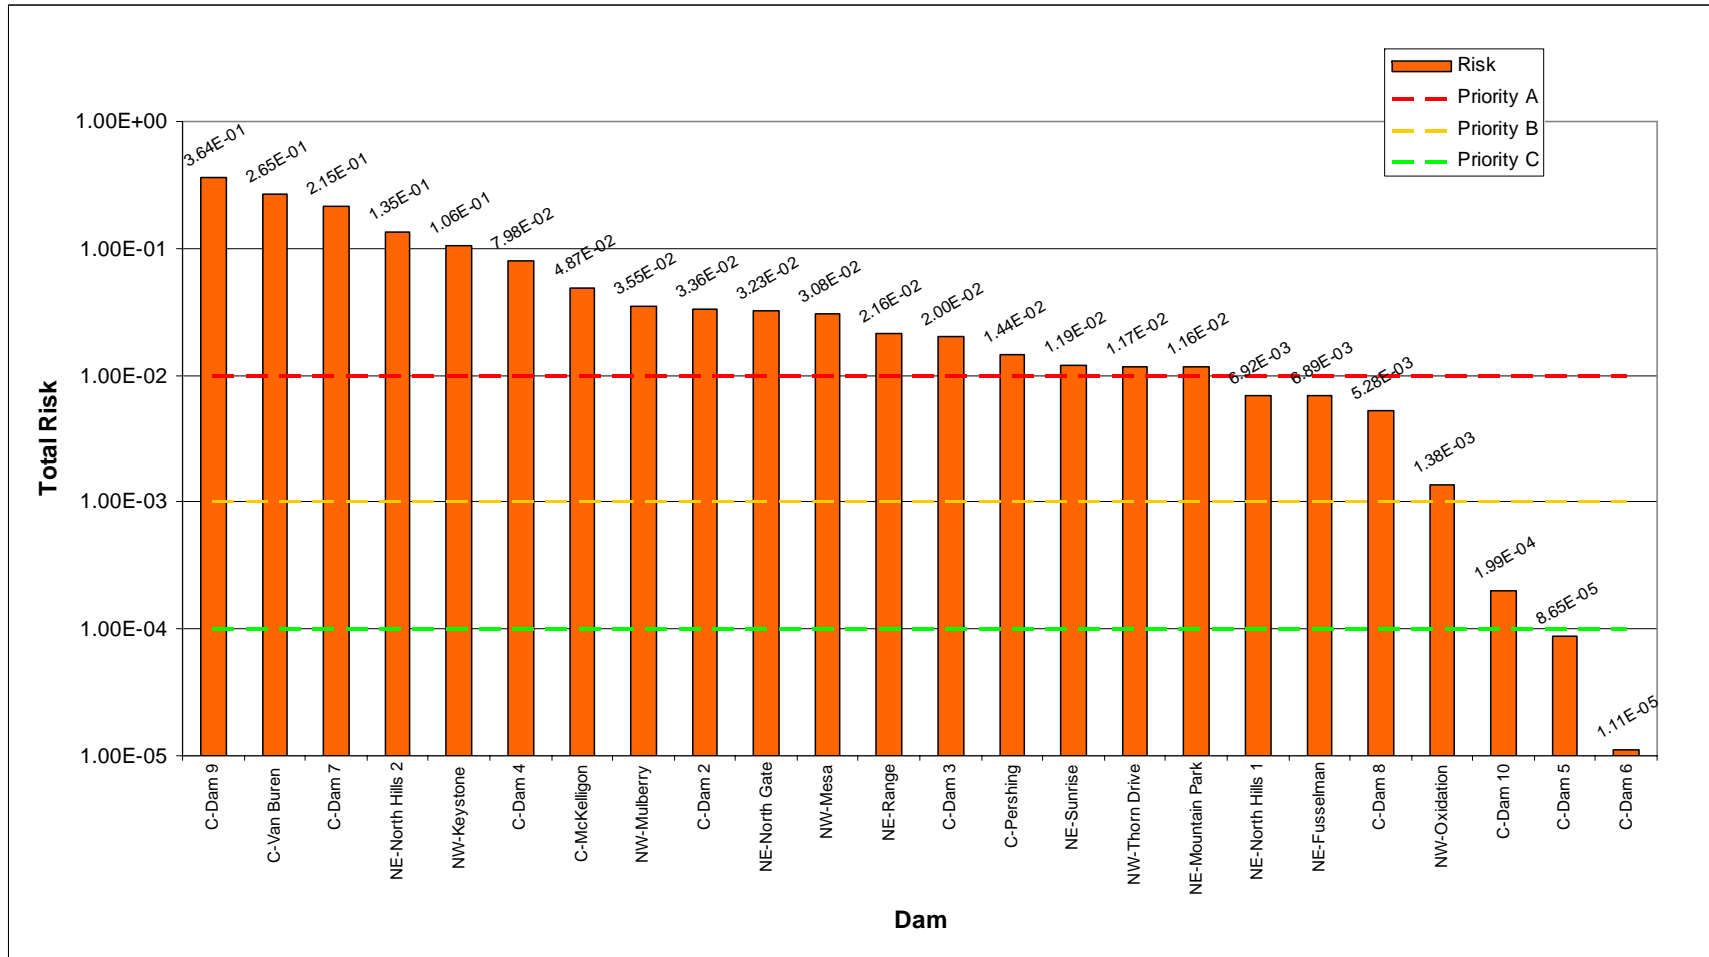
Figure D-3a. El Paso Water Utilities Dam Portfolio Total Risk Profile

The El Paso Dam Total Risk Profile is presented in Figure D-3a. Figure D-3a ranks the total annualized lives risk of each of the dams relative to the different priority classifications. According to Figure D-3a, 17 of the 24 El Paso dams are Priority A classification. Of the remaining dams, 4 dams are Priority B, 1 dam is Priority C, and 2 dams are below Priority C. Over 70% of the dams that were analyzed received an overall Priority A classification, prompting further review of the results. Table D-1 shows those 17 dams listed by watershed, their contributing failure mode(s) with Priority A and B classification noted, as well as the LLP values for each dam. The most useful means to review the assessment results is to focus on two aggregations of the failure modes -- overtopping (i.e. risk due to hydraulic inadequacy) and piping/conduit -- and to review those results separately.

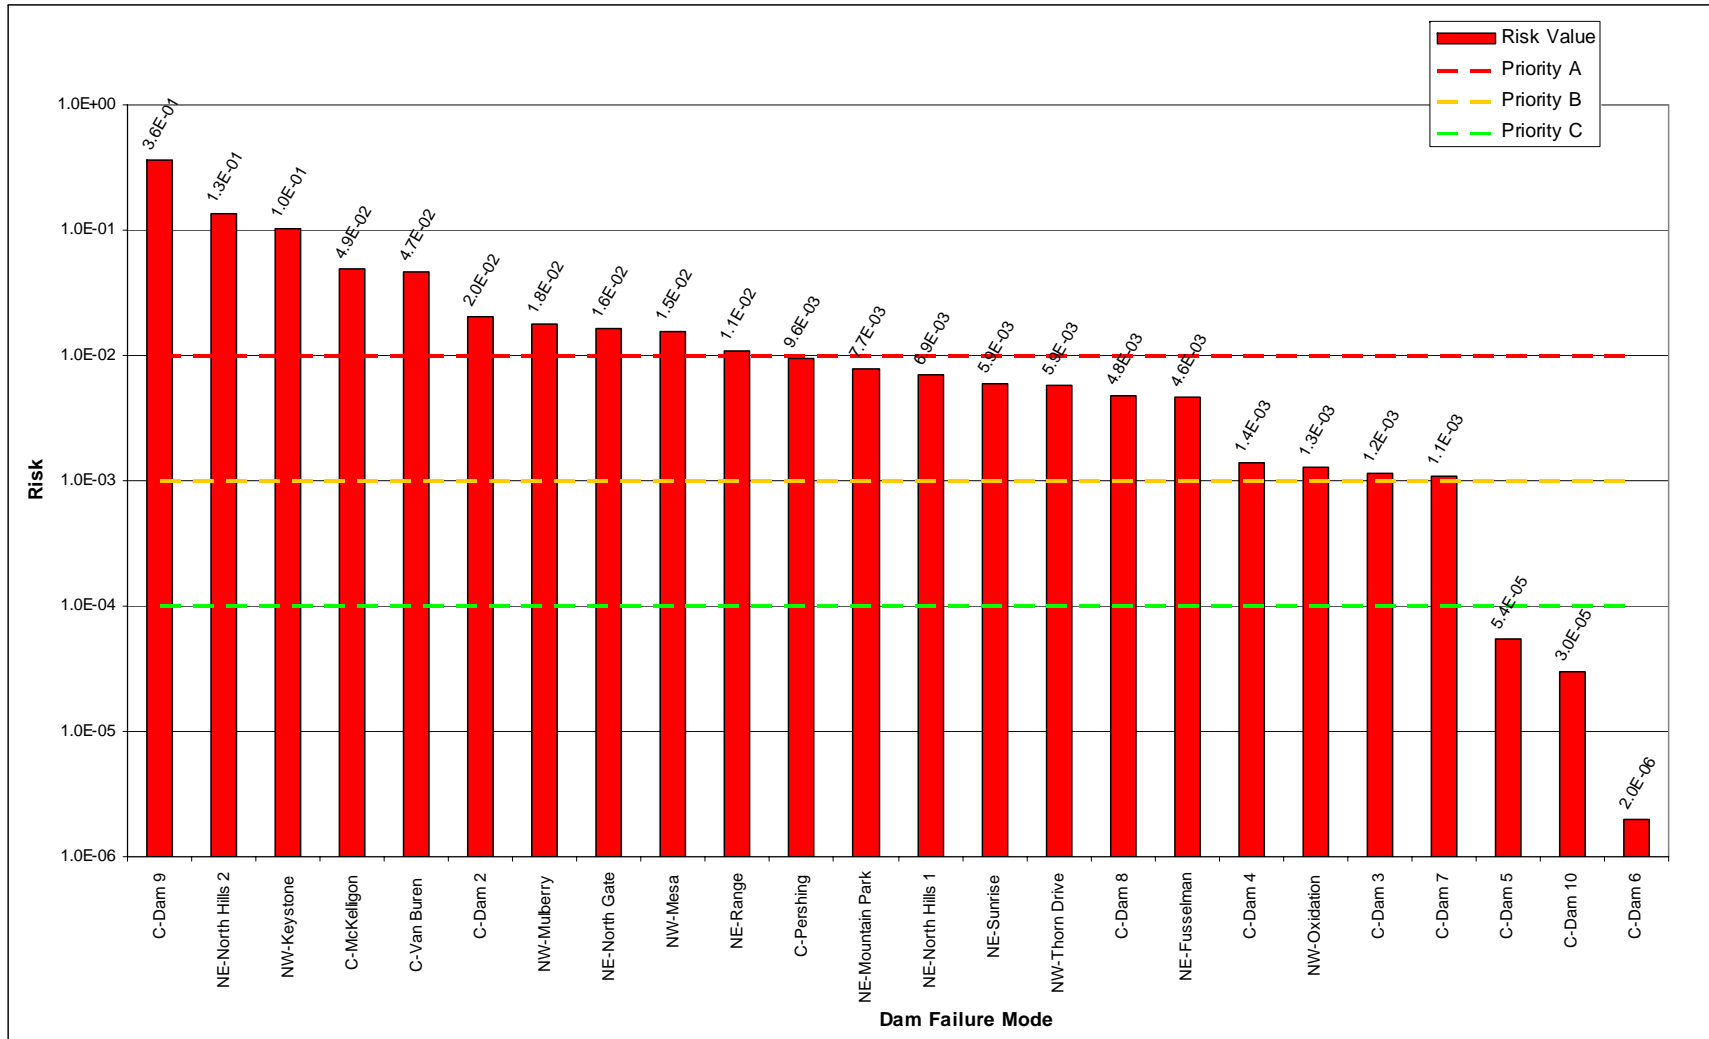
Figure D-4. El Paso Water Utilities Dam Portfolio Risk Profile by Piping and Conduit Failure Modes

Figure D-4 shows the risk by piping and conduit failure modes and expresses the probability of failure of the 24 dams based on those two failure modes. According to Figure D-4, analyzing only piping and conduit failure modes, 10 of the 24 El Paso dams receive Priority A classification. Of the remaining dams, 11 dams are Priority B and 3 dams are below Priority C. An analysis of this risk demonstrates that the consequence of failure (e.g. lives at risk) rather than probability of failure drives the high risk ranking in almost all cases, as shown in Figure D-5. In other words, the density of population downstream of the dam is so high that even a low risk of failure results in the failure mode receiving priority attention.

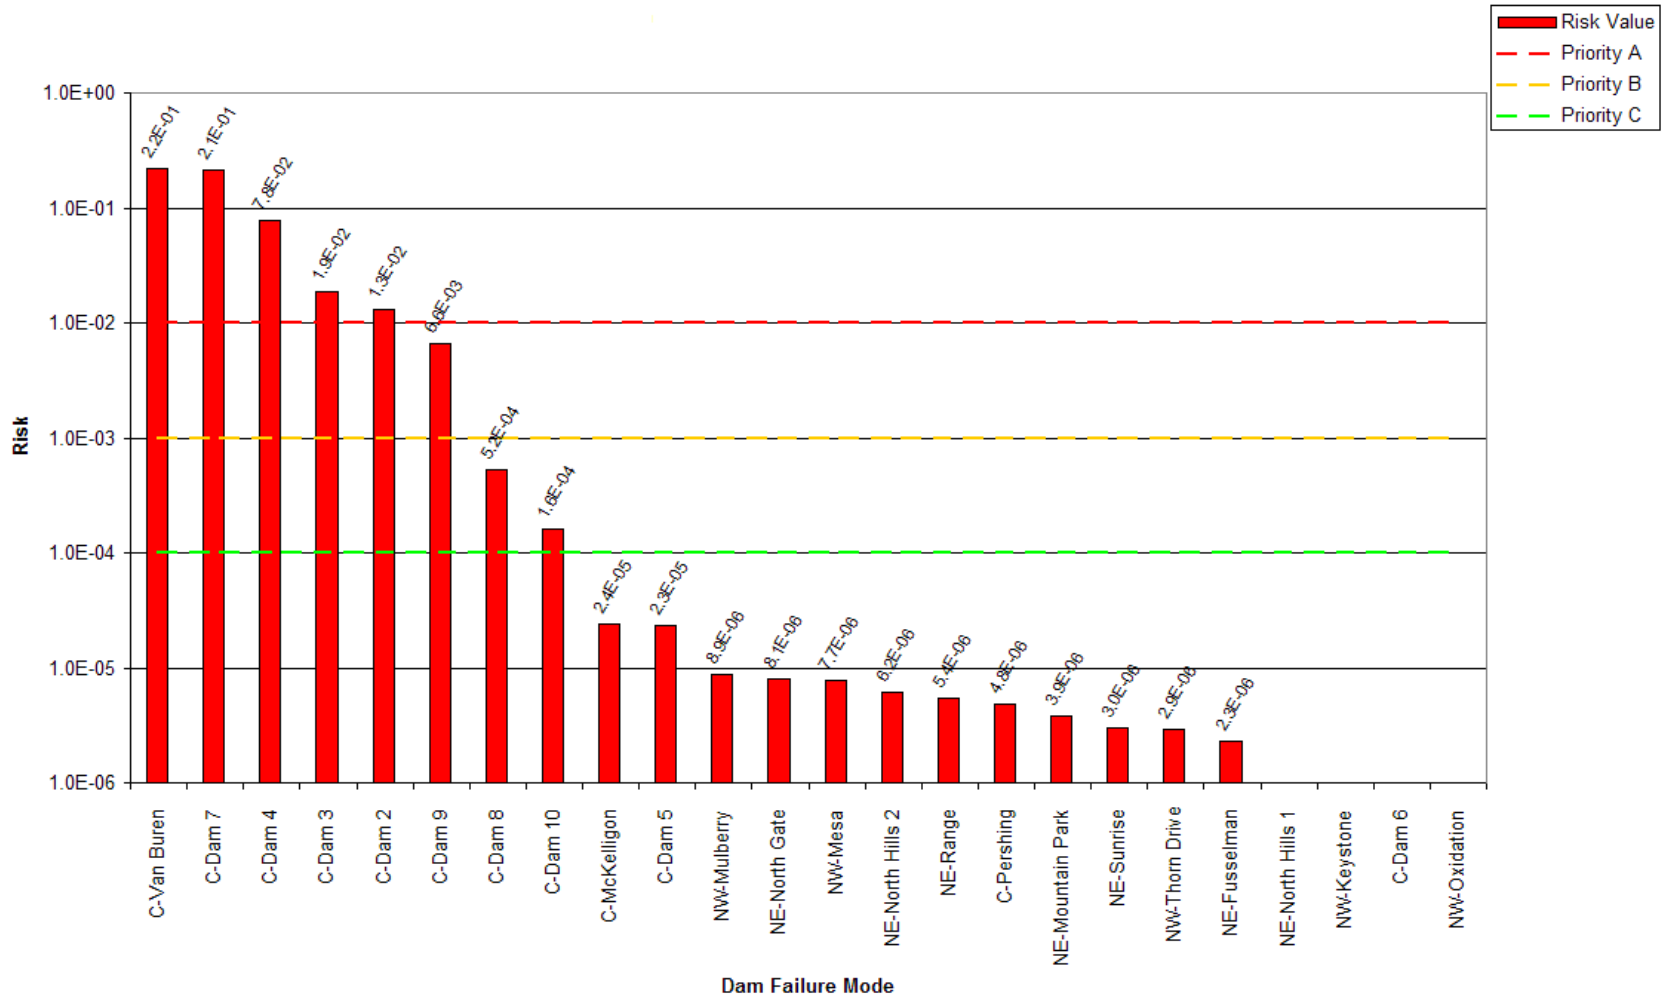
Figure D-6. El Paso Water Utilities Dam Portfolio Risk Profile by Flood Failure Mode

Figures D-6 and D-7 present the results of the risk analysis for the flood failure mode. This analysis shows that when considering flood failure mode alone, only 5 of the 24 El Paso dams receive Priority A classification, 1 dam is Priority B, 2 dams are Priority C, and the remaining 12 dams are below Priority C. This clearly demonstrates that the risk of dam failure due to overtopping of the dam is not a major concern for the majority of the dams. The five Priority A dams for flood failure mode are Van Buren Dam, Dam 7, Dam 4, Dam 3, and Dam 2. The return period for the storms estimated to cause

overtopping of these Priority A dams are each substantially less frequent than the 1000-year flood; i.e. the risk of overtopping is substantially less than the risk of flooding associated with each project identified in Section 6.0. As with piping failure, a review of the analysis shows that the consequences rather than the probability of failure are the driving force behind the high risk values as shown in Figure D-7. The elevated estimated risk of these dams is created by the large populations located immediately downstream. These dams are all in the Central Watershed.

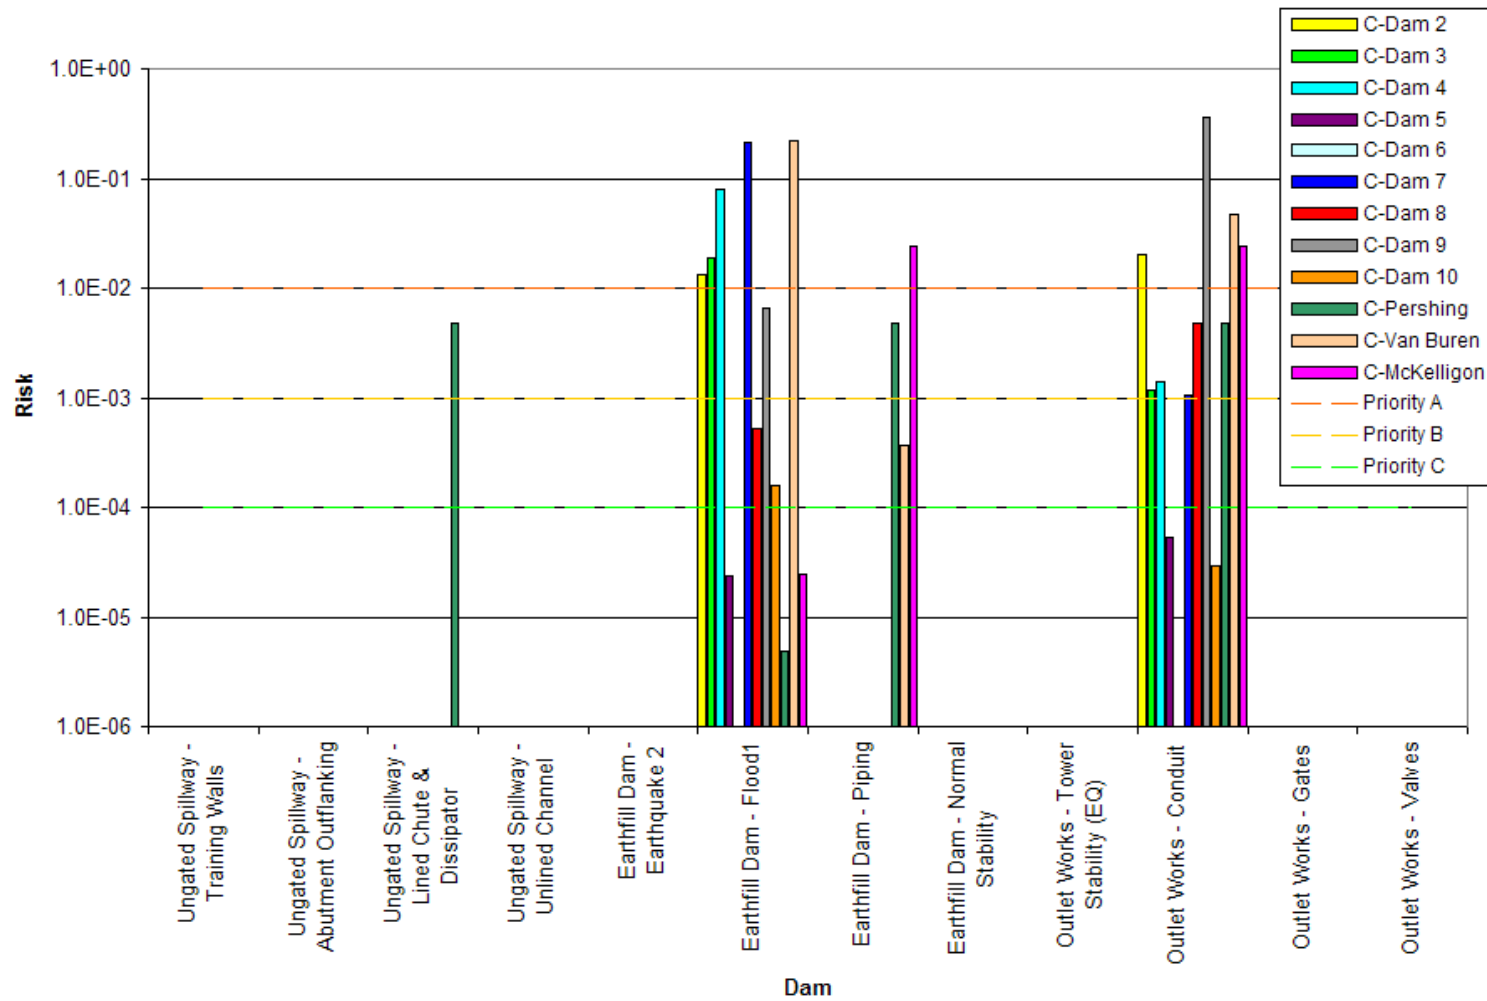
Figure D-8. Dam in the Central Watershed - Risk by Dam Failure Mode

Figures D-8, D-9, and D-10 show the risk for each dam by each specific failure mode for the Central, Northeast and Northwest watersheds respectively.
